City of Canandaigua Feasibility Analysis for Building Rehabilitation and Re-Use

NEW YORK MAIN STREET TECHNICAL ASSISTANCE PROGRAM

February 9, 2021

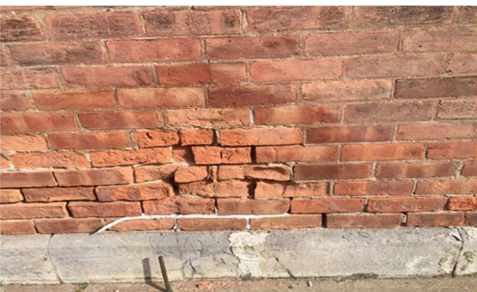
Rear Elevation, Detail of deteriorated brick

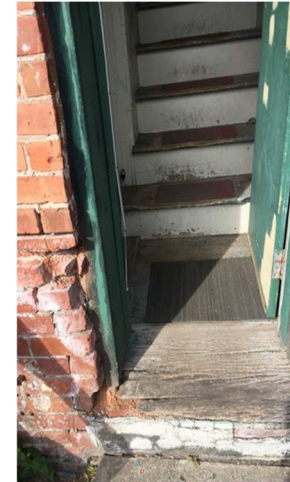
Rear Elevation, Detail of deteriorated brick

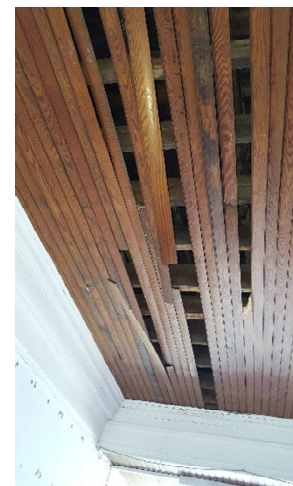
3rd Floor, Detail of ceiling water damage
